2017 DAMAGE PREVENTION CASE STUDIES

MN OFFICE of PIPELINE SAFETY

A division of the Minnesota Department of Public Safety

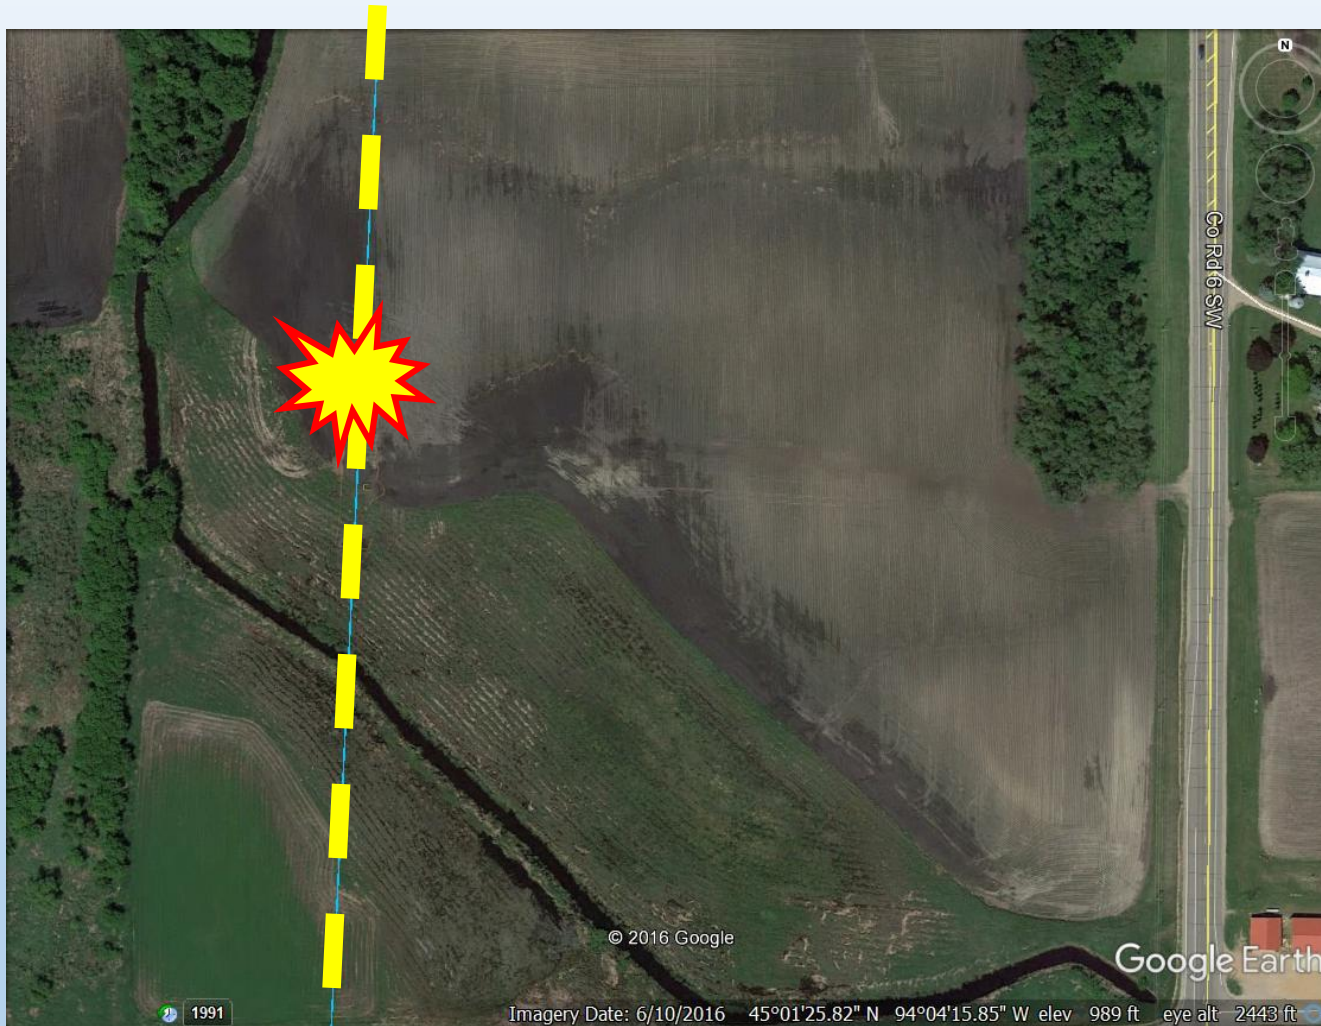
- **3" Steel Natural Gas Transmission Line**
- **Howard Lake Area**
- **7,000+ MCF Gas Release Before Bypass Installed**

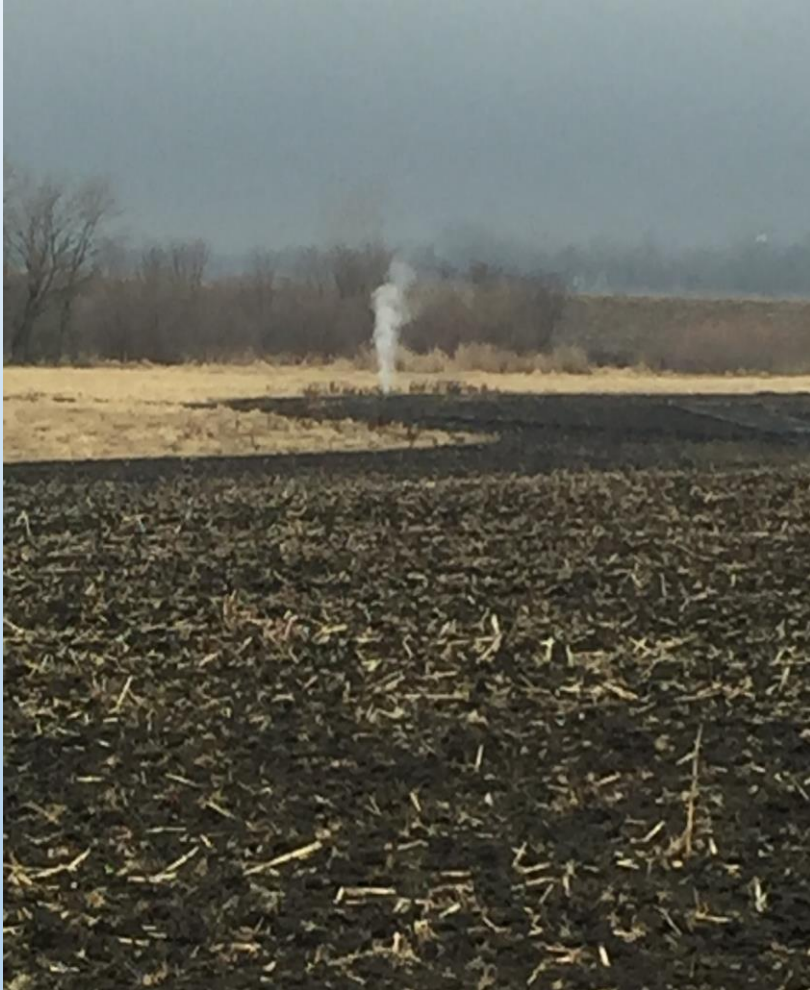
20-ft High Flume

Pipe Flattened

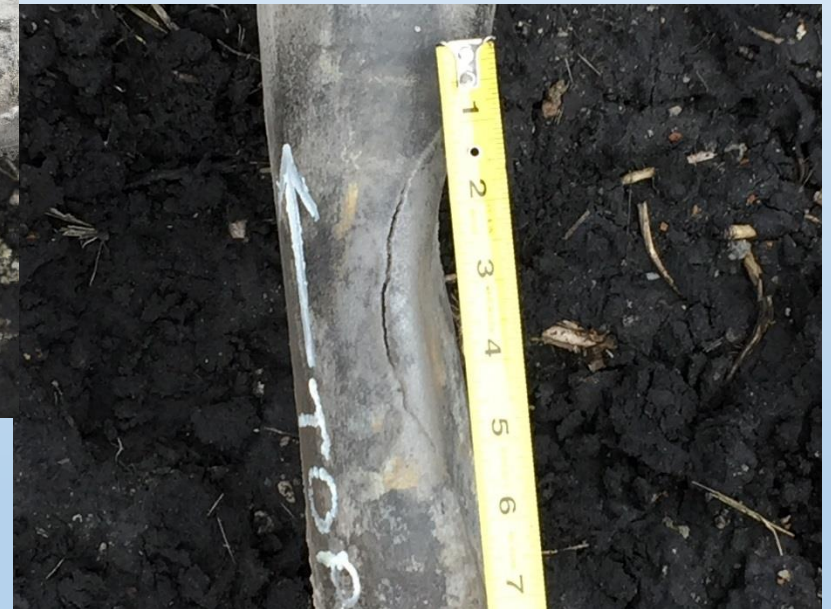
2-in by 1/16-in Crack

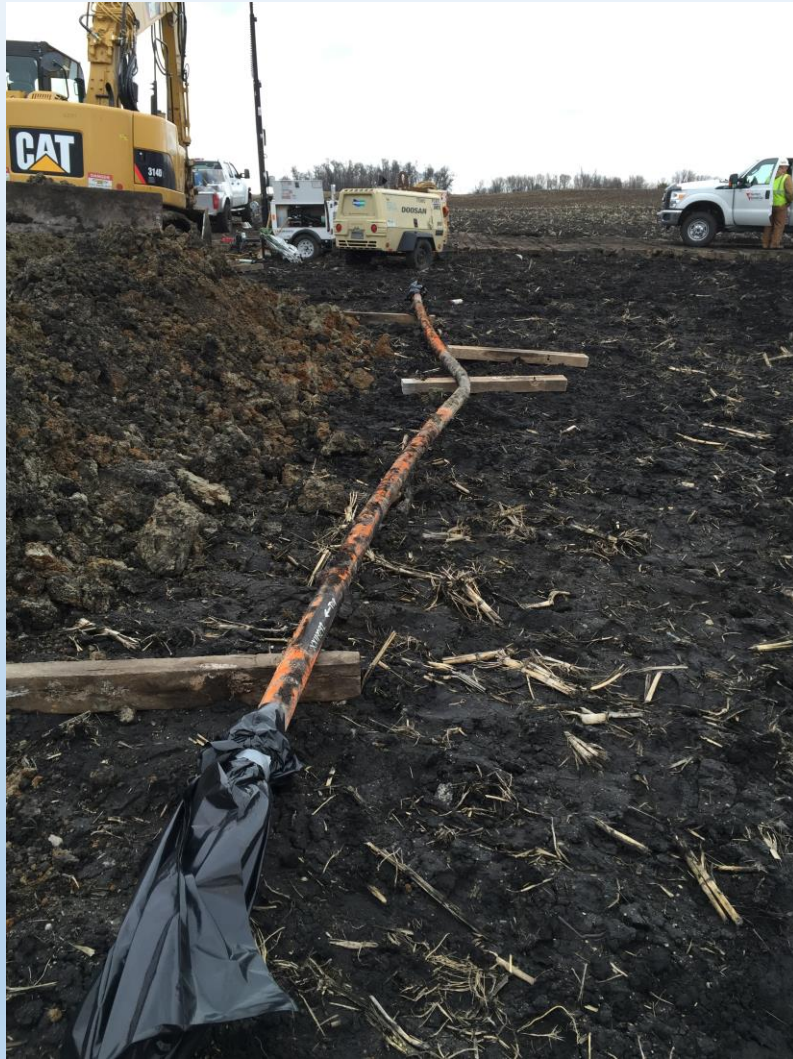
Damaged Section

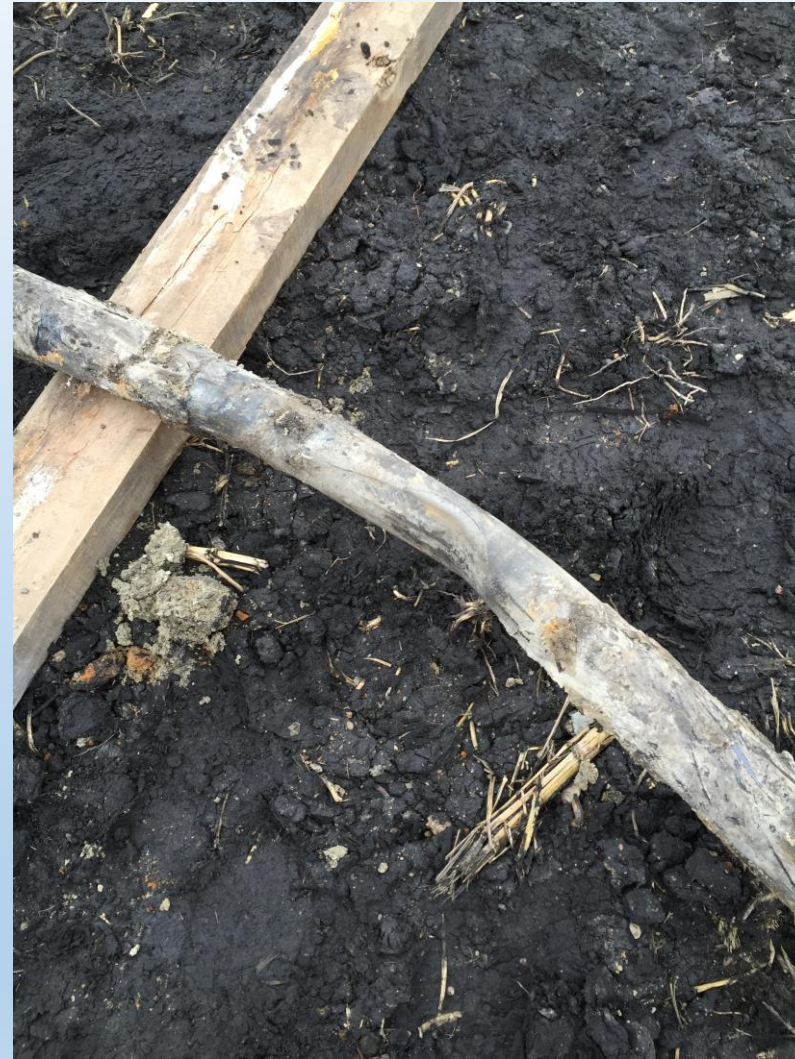
Crest of Bend

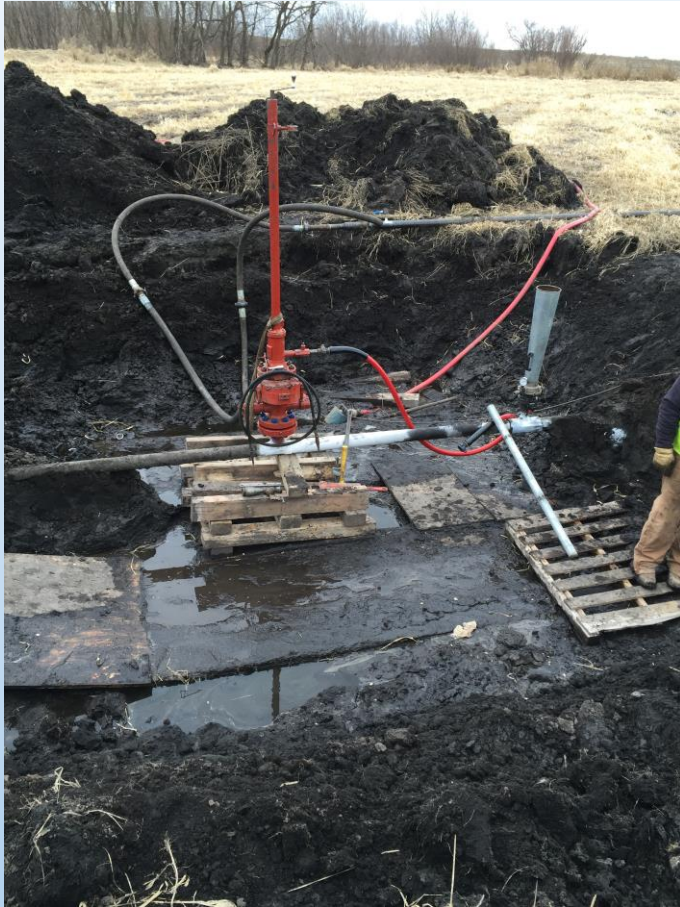
Stopple/Bypass

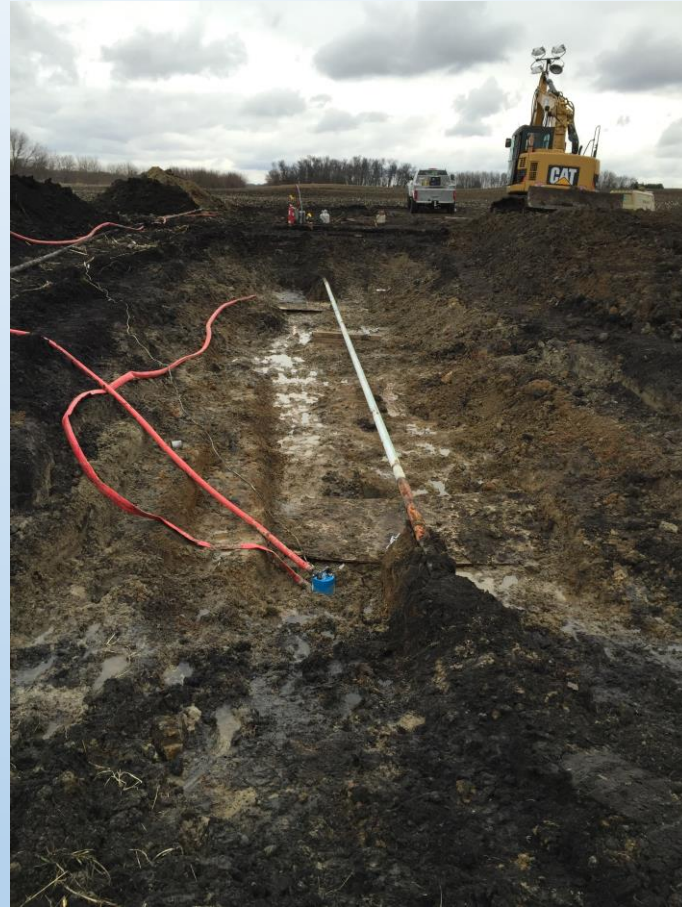
Replaced Section

- **Generally 30-in of Ground Cover**
- **20-in of Ground Cover at Damage Site**
- **2 – Stopples and Bypass Used for Repair**
- **37-ft of Pipeline Replaced**
- **No Interruption of Service - Four Cities at Risk**
- **Repairs Required 4-days**

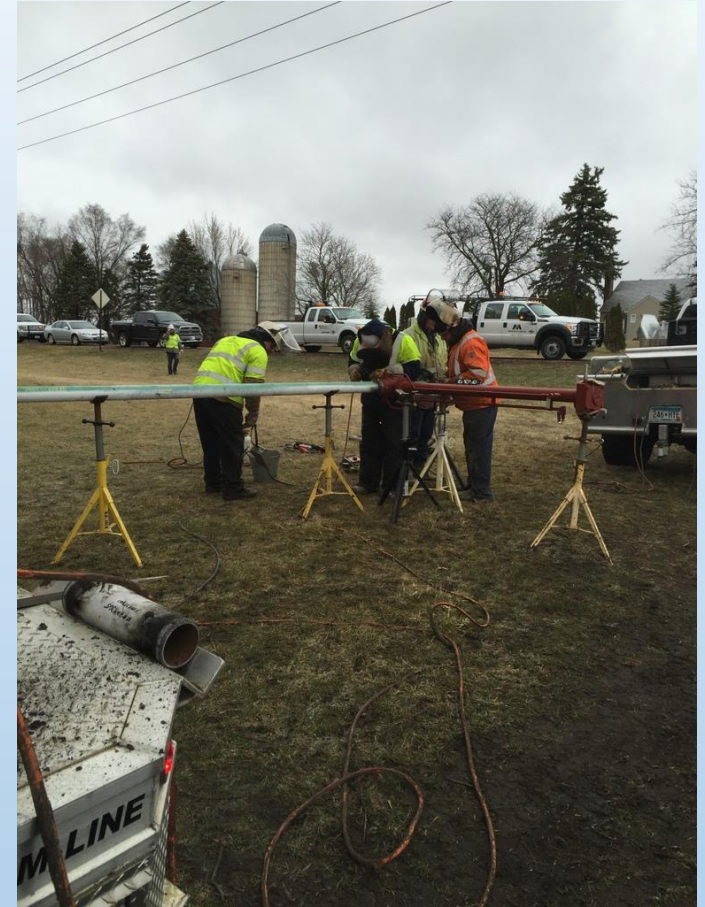
New Block Valve

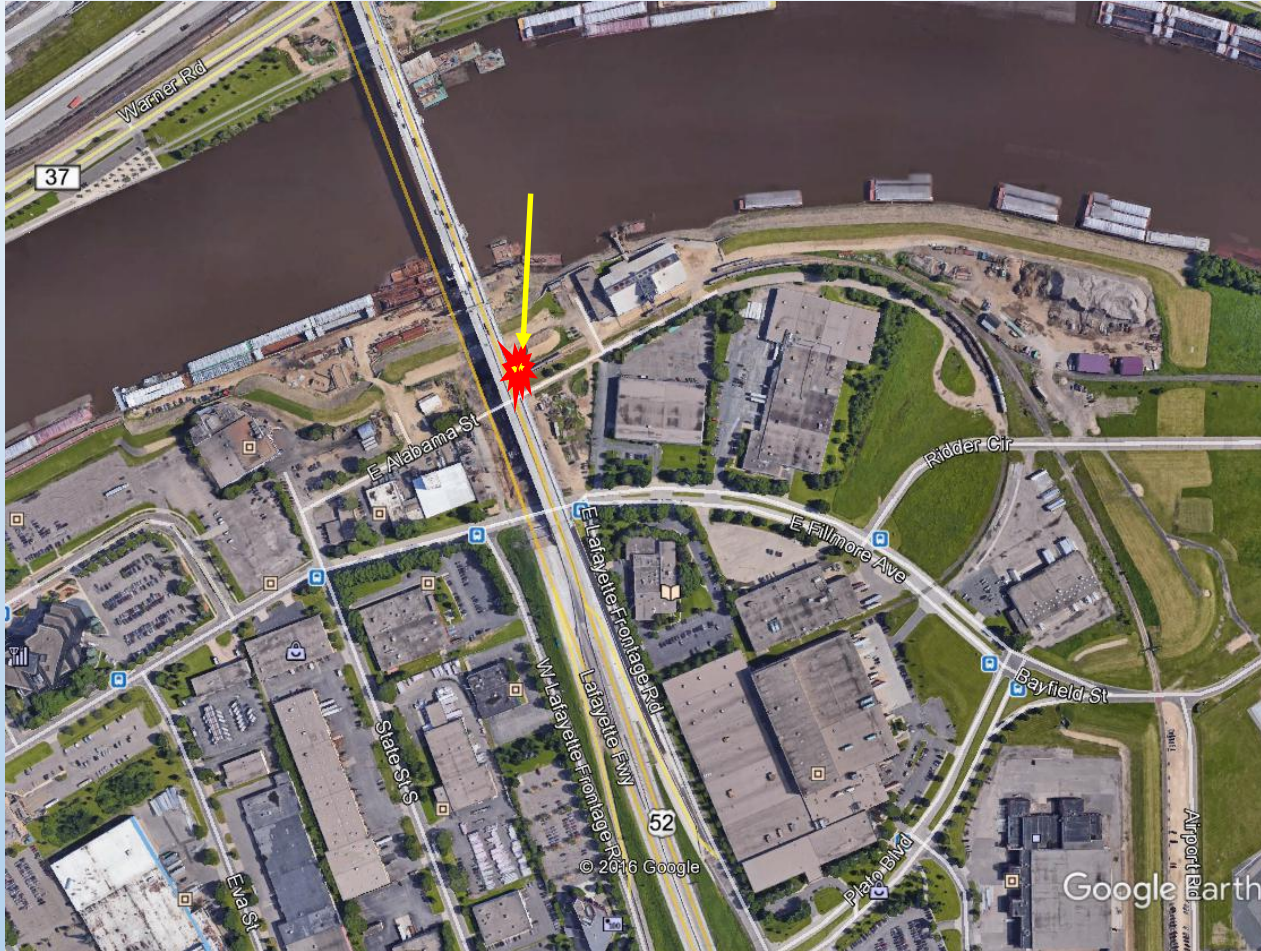
- St. Paul Industrial Area
- 4" Polyethylene Natural Gas Main, 22-66 psi
- Local Business Evacuated (16 people)
- Media Onsite
- Street Traffic Blocked off

3rd Party Gas Main Hit While Excavating for New Pond

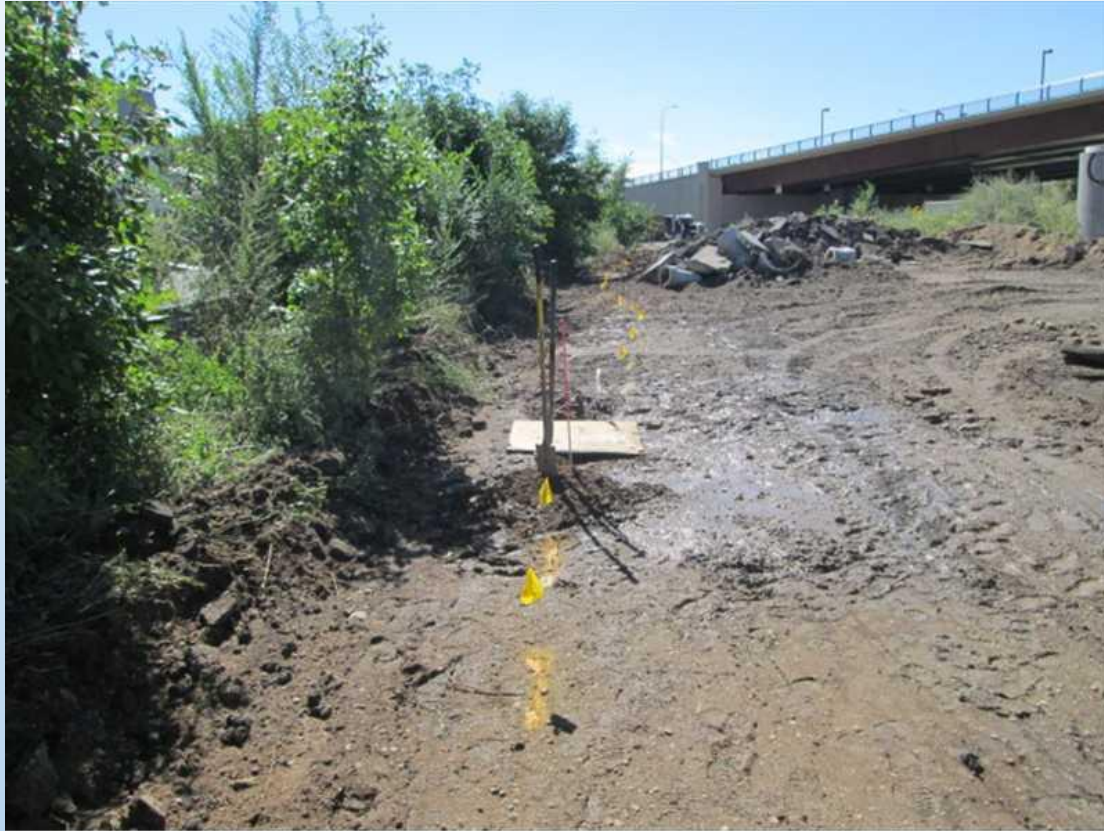
**Northerly View - Initial
Locates 9/10**

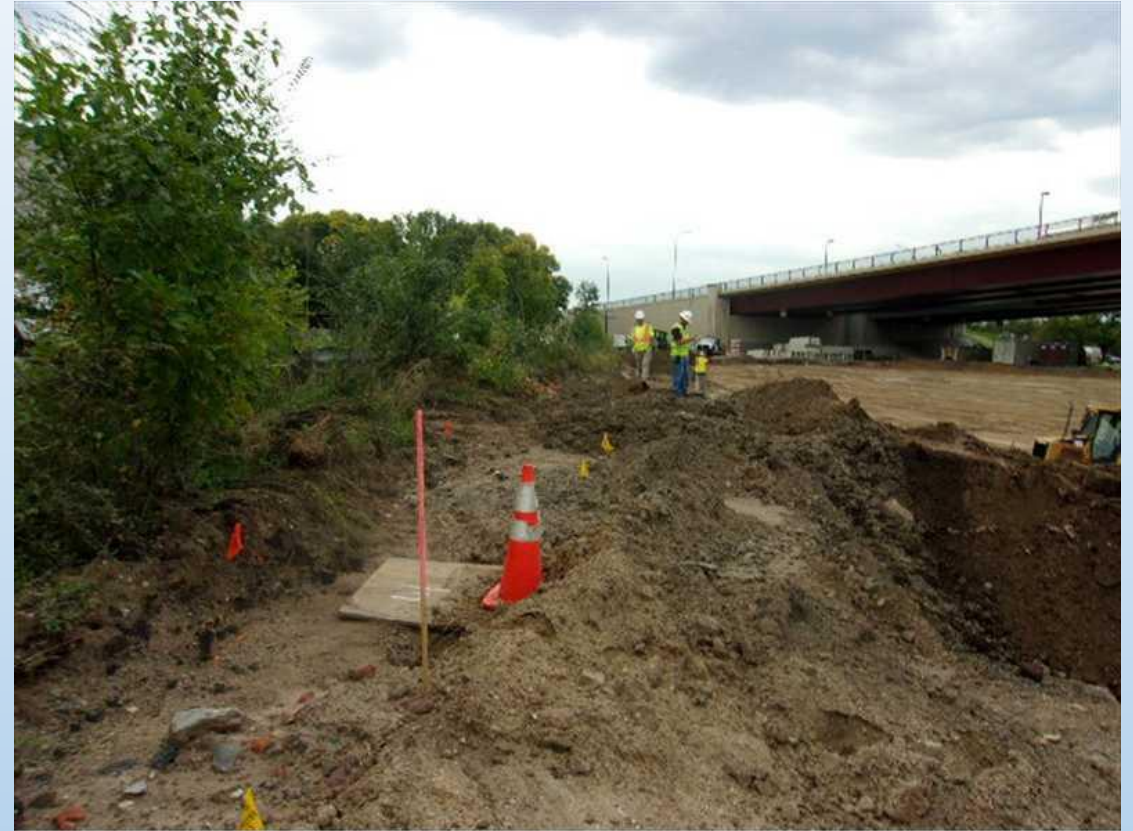
**Northerly View - Post
Damage Locates 9/28**

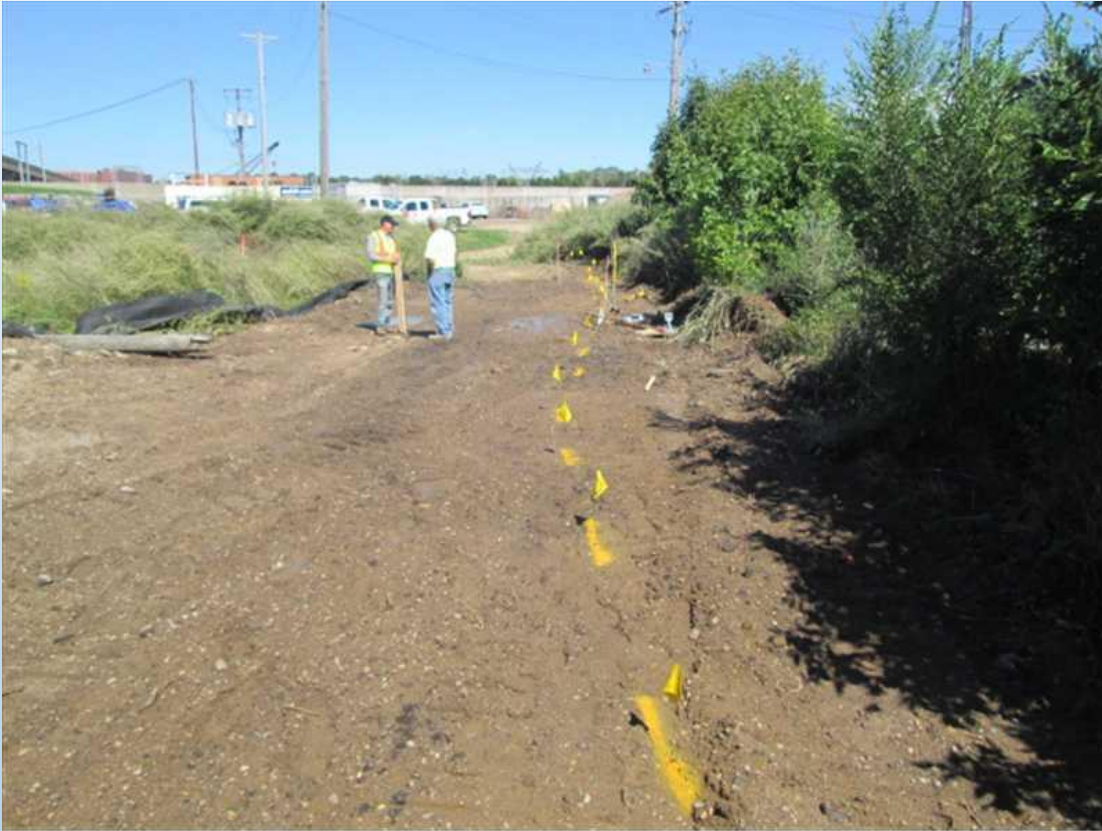
**Southerly View - Initial
Locates 9/10**

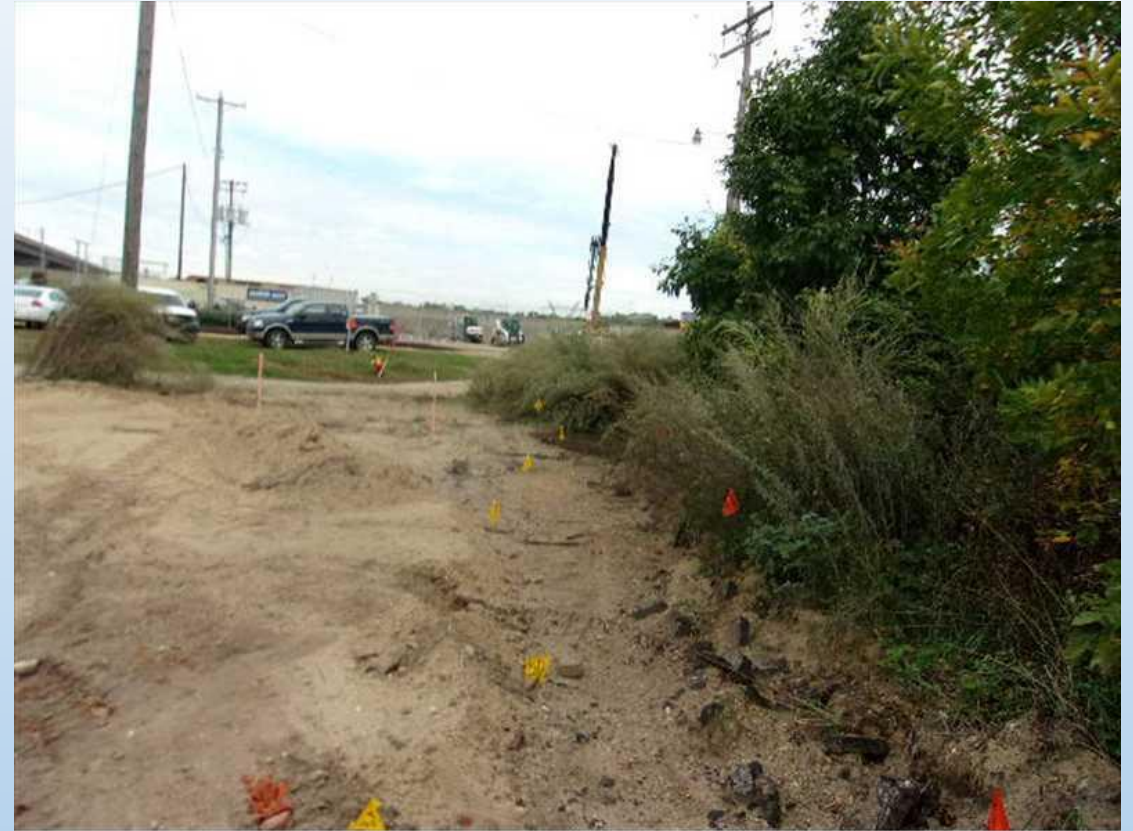
**Southerly View - Post
Damage Locates 9/28**

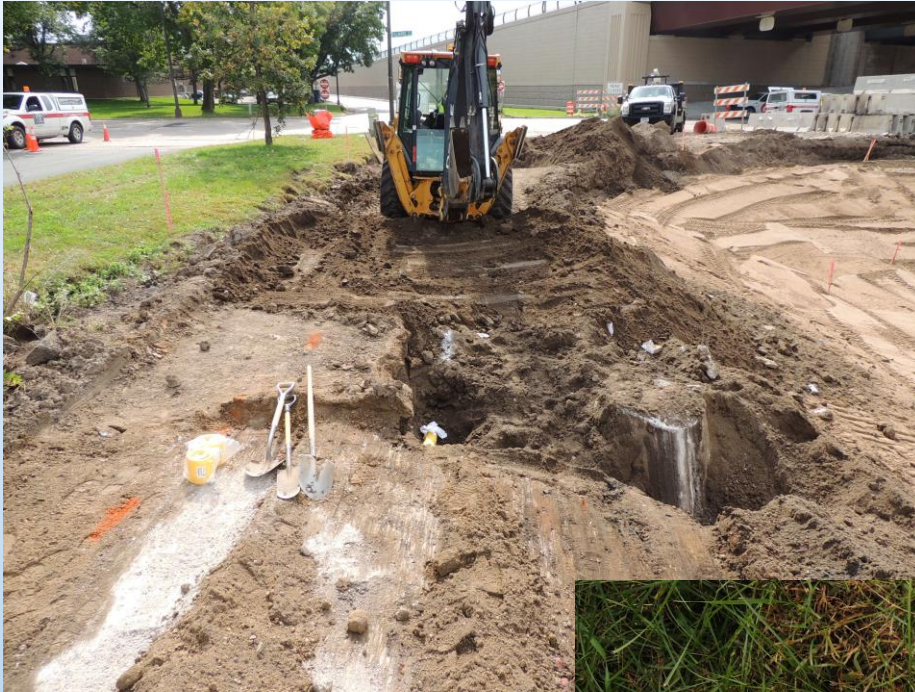
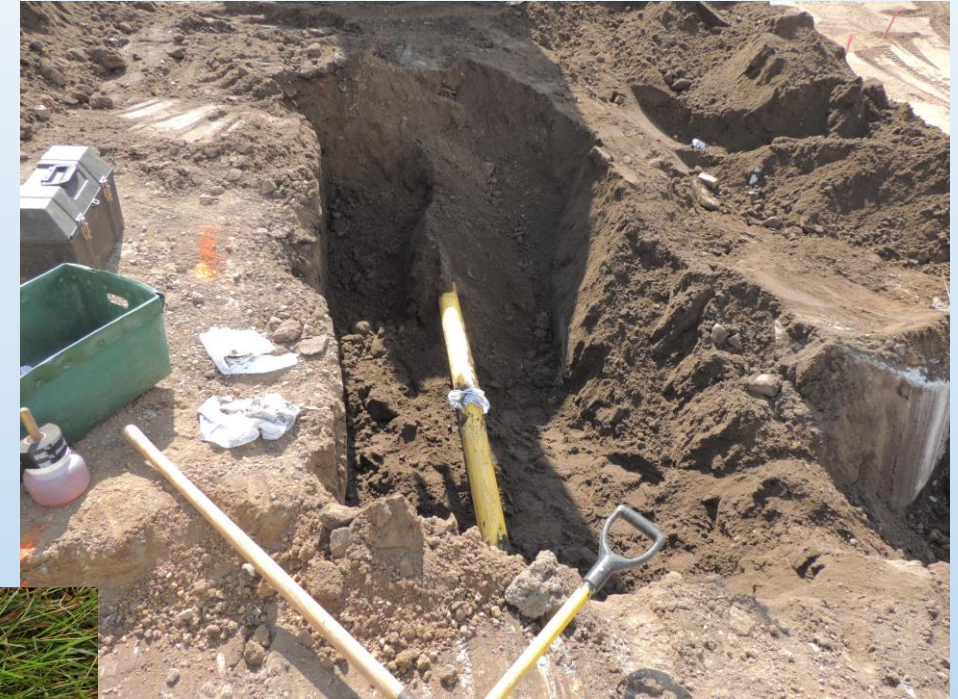
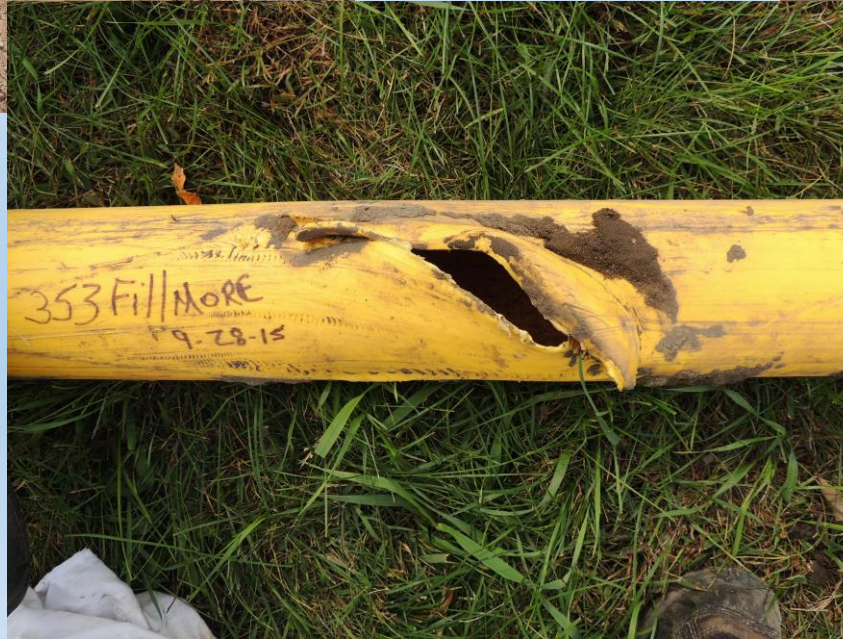
**3rd Party
Excavation Damage**

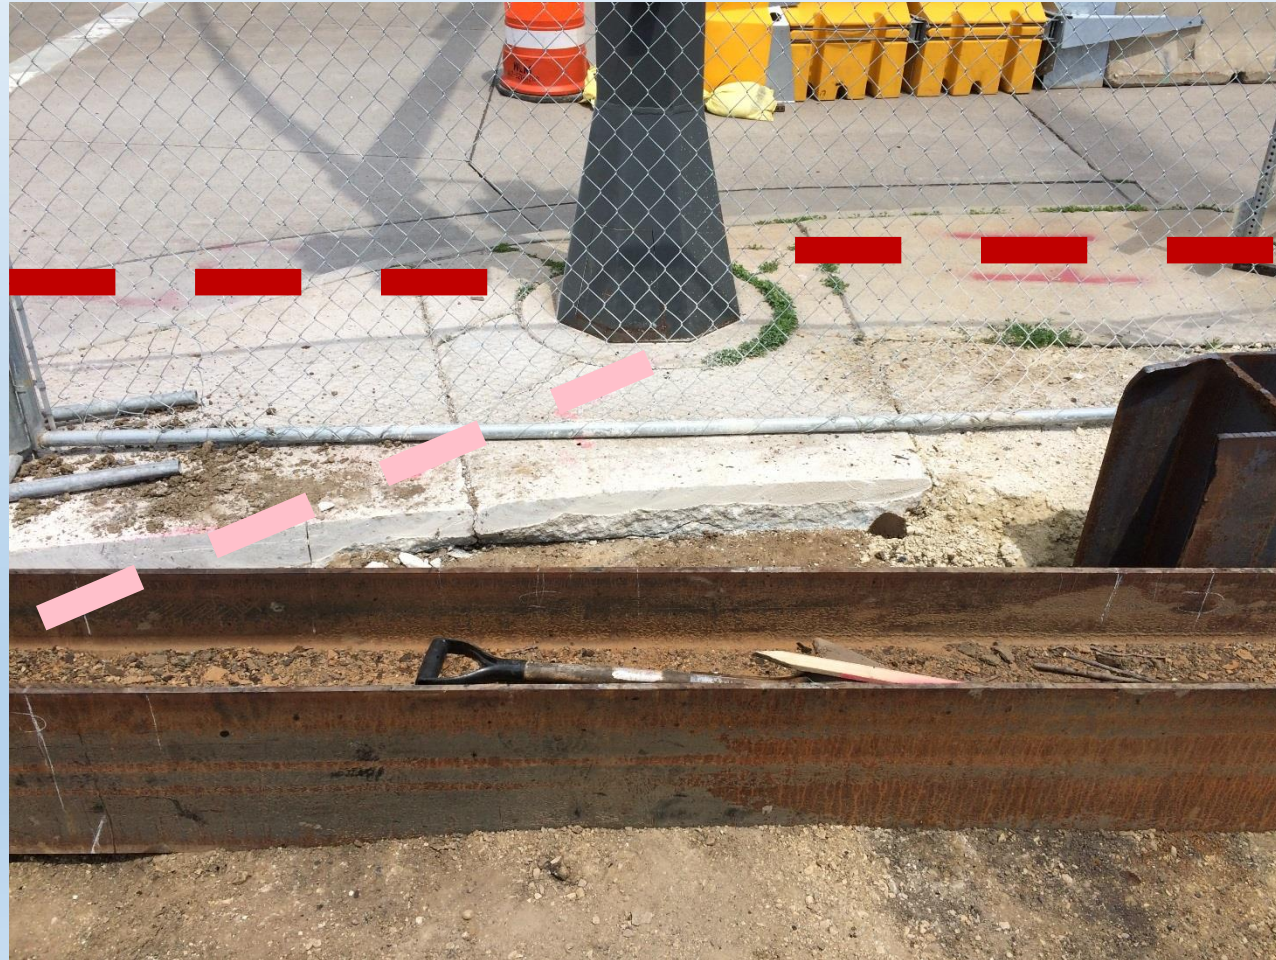
Pink Paint

- Utility was marking traffic signal wires with pink paint to distinguish between electrical lines
- Surveying onsite was using pink paint per APWA standard
- The excavator was not looking for pink paint because it doesn't represent a utility

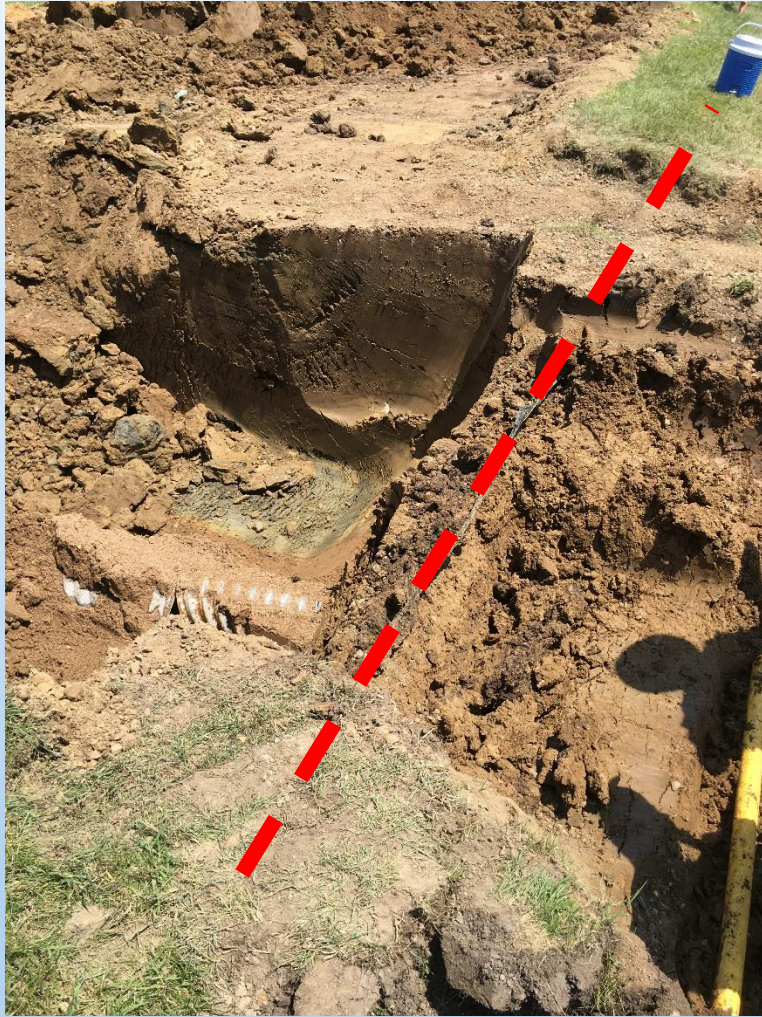
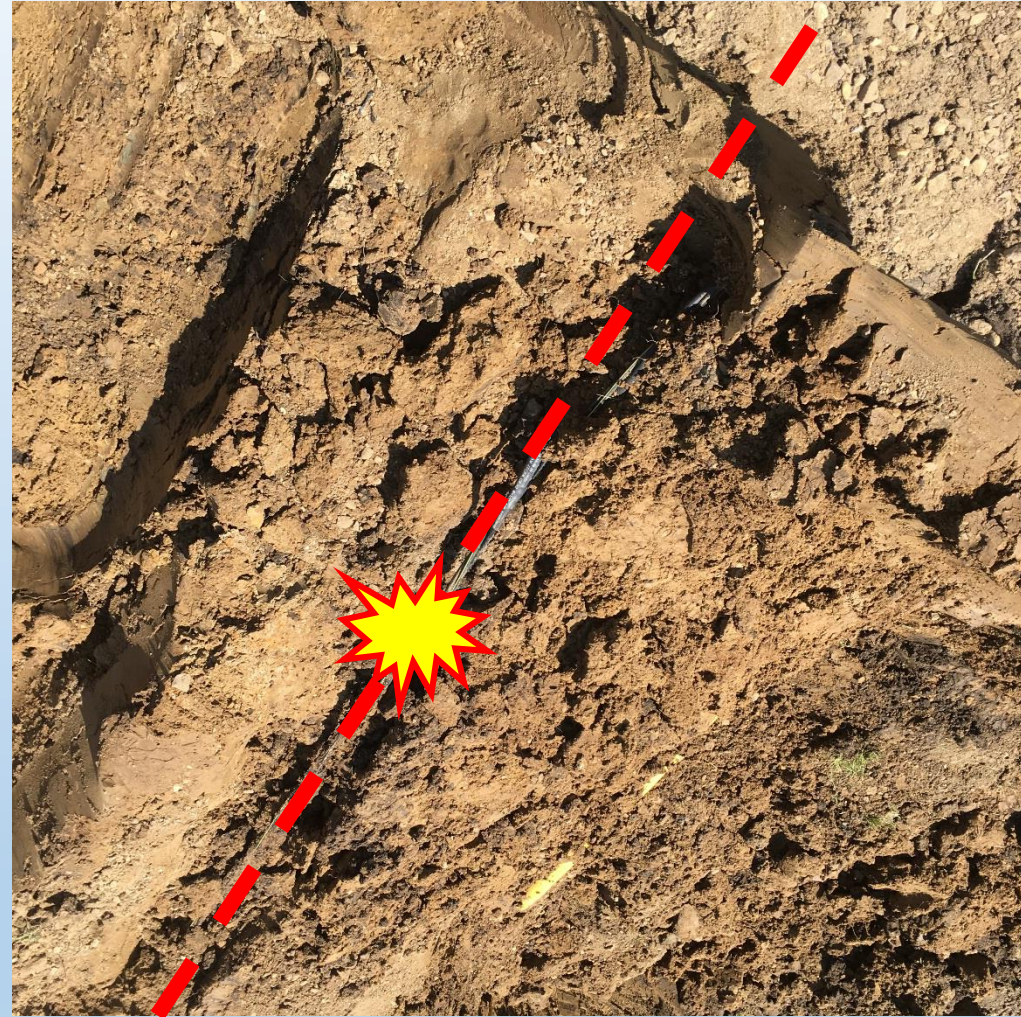
Electrical Secondary Line Hit by Shovel

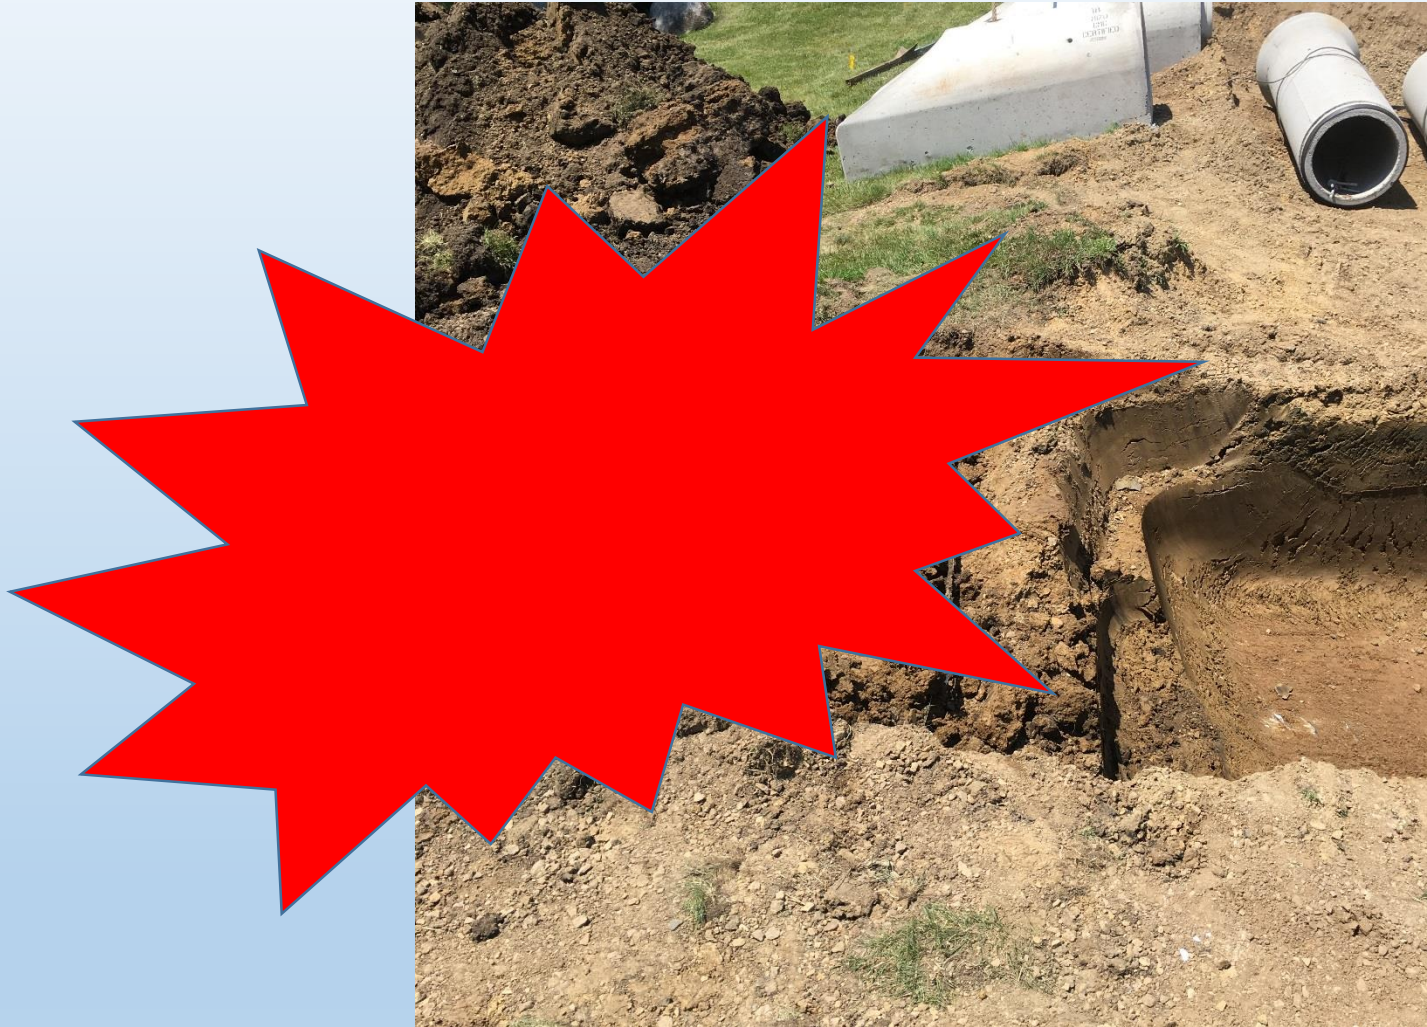
Worker Was Jolted Out of the Hole
