2017 DAMAGE PREVENTION CASE STUDIES

MN OFFICE of PIPELINE SAFETY

A division of the Minnesota Department of Public Safety

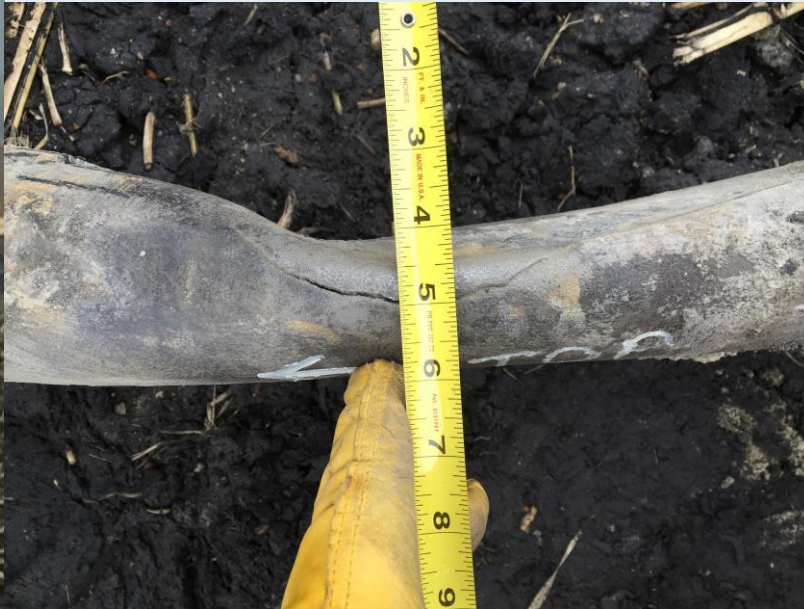
Pipe Flattened

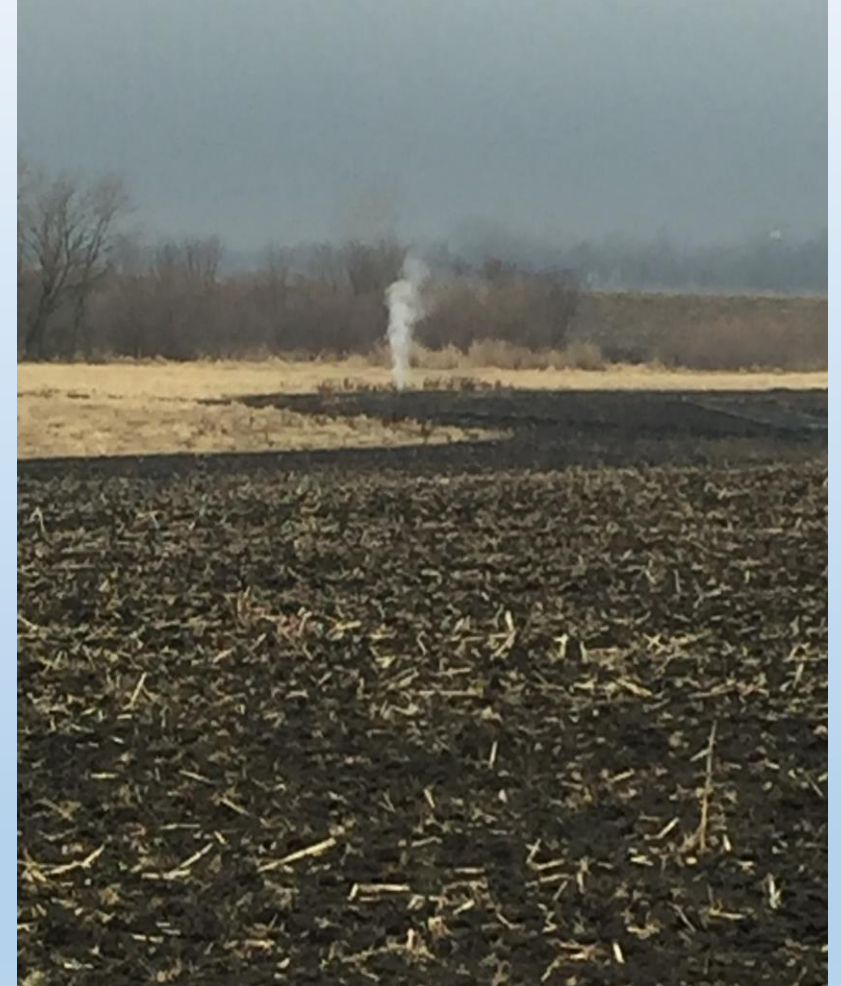
- **Generally 30-in of Ground Cover**
- **20-in of Ground Cover at Damage Site**
- **2 – Stopples and Bypass Used for Repair**
- **37-ft of Pipeline Replaced**
- **No Interruption of Service - Four Cities at Risk**
- **Repairs Required 4-days**

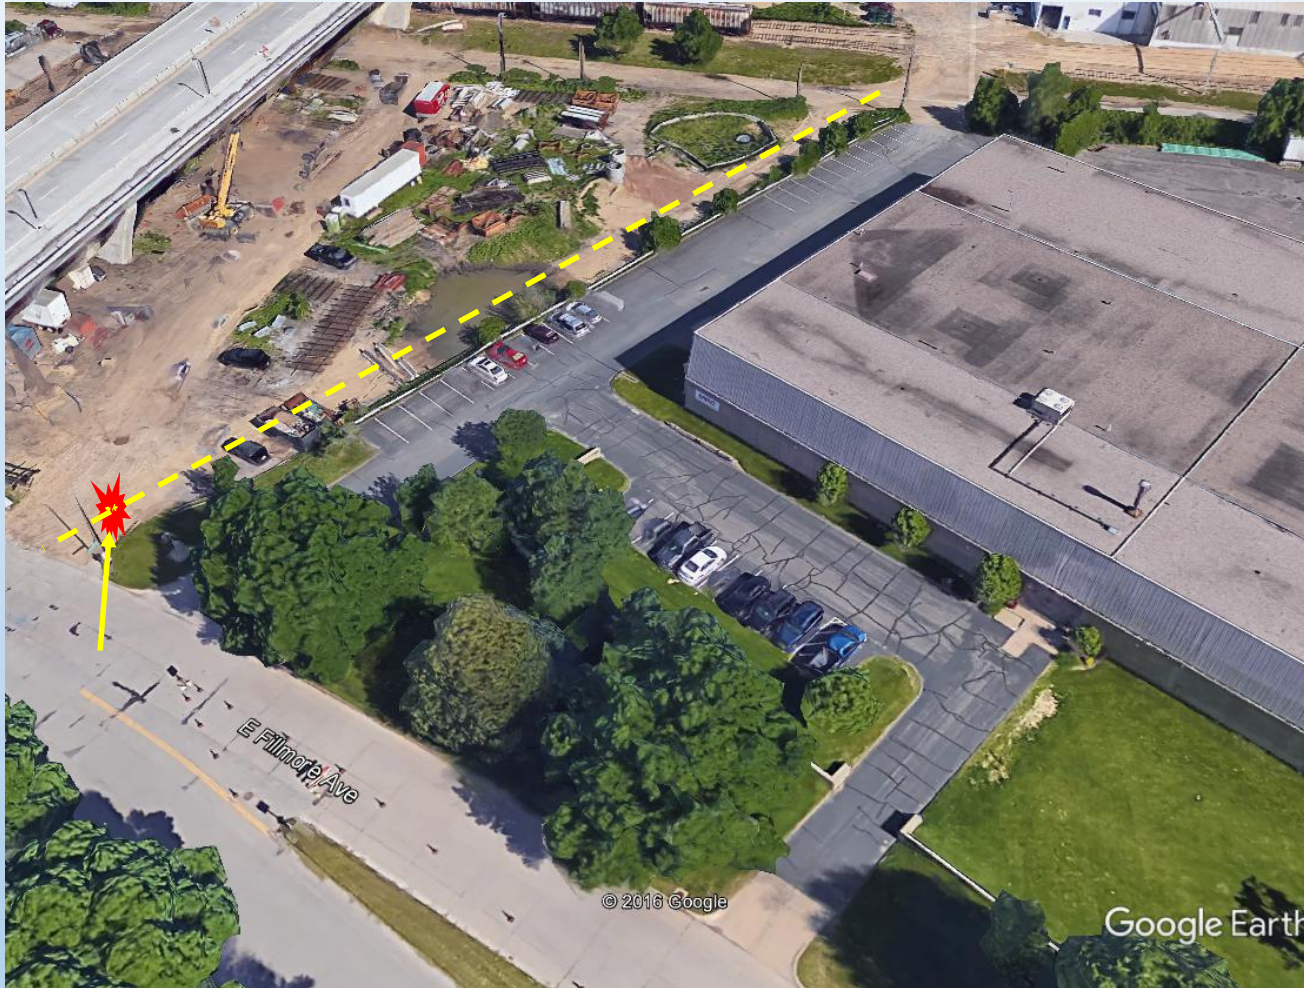
- GSOC Ticket Submitted 9/4
- Work Date 9/9
- Expiration Date 9/23
- Damage Date 9/28
- No Refresh Request
- Marks Not Maintained

3rd Party Gas Main Hit While Excavating for New Pond

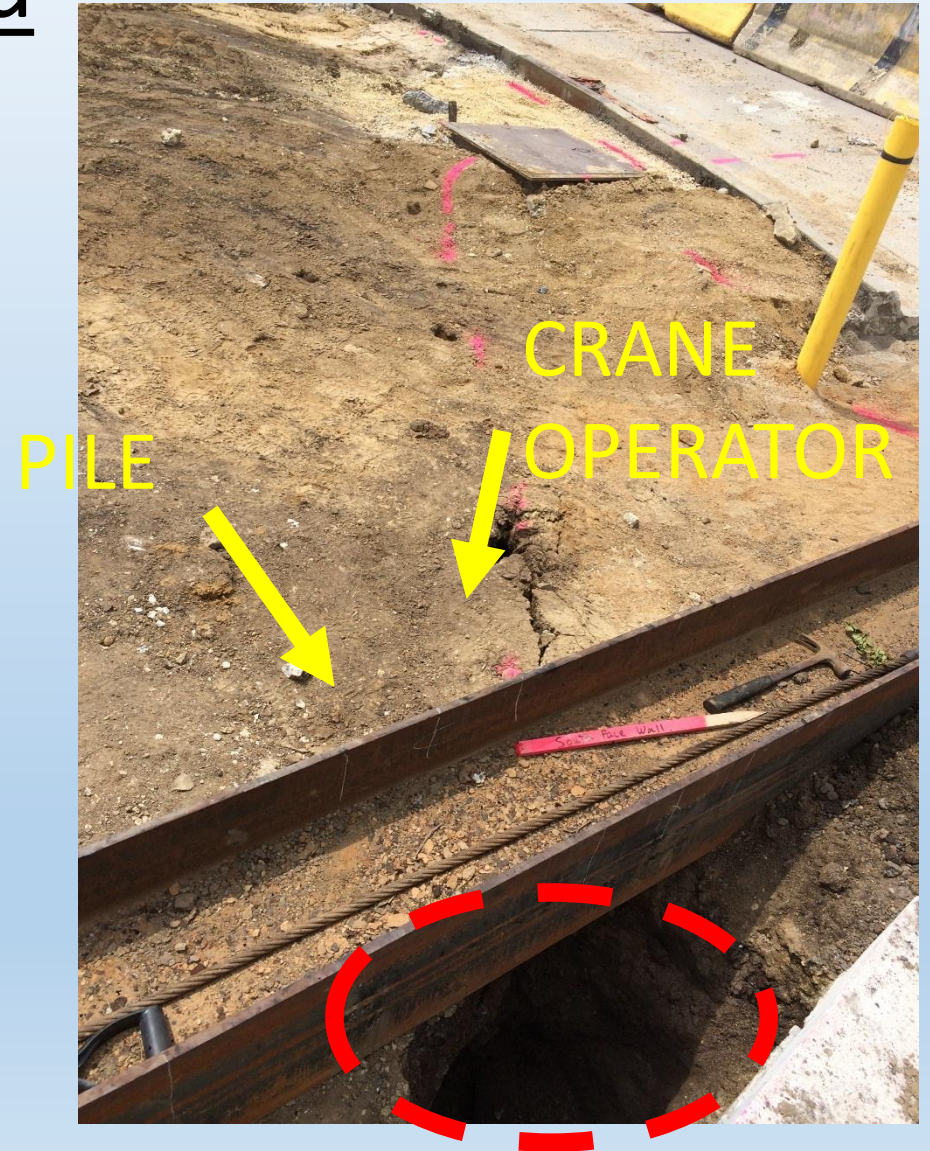
- Crane operator begins driving first pile
- After three hammer blows intersections lights start flashing
- Stop work and expose hole made by pile
- Find cut traffic wire
- Start to notice a lot of pink paint around work area

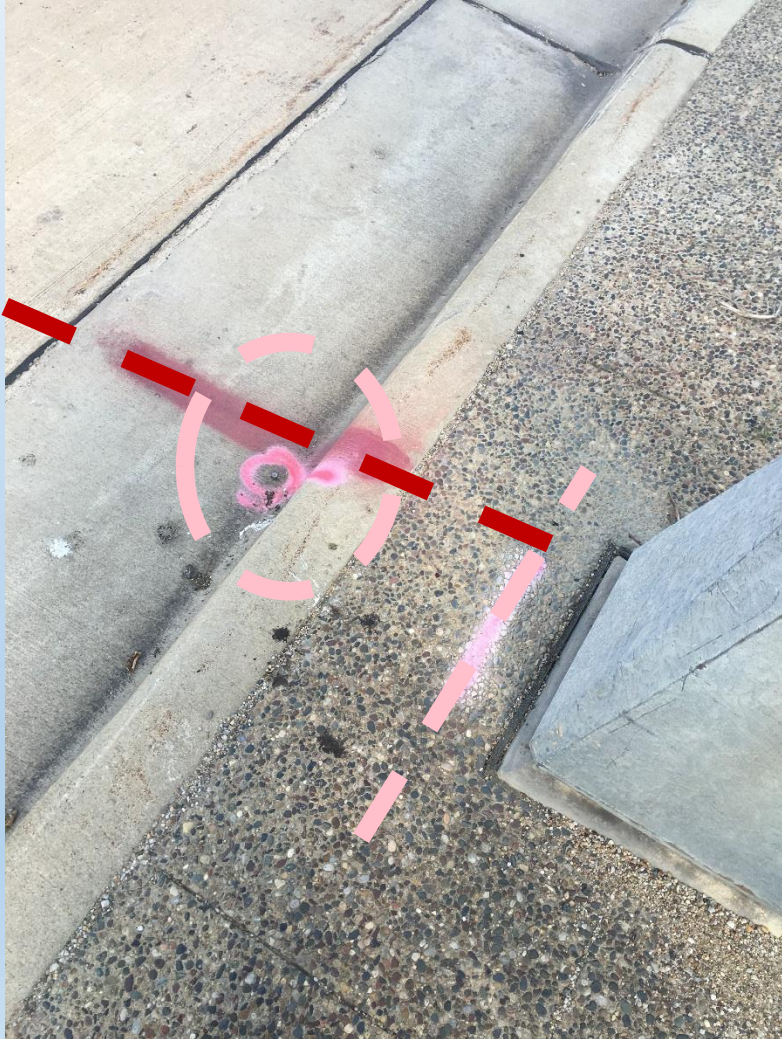
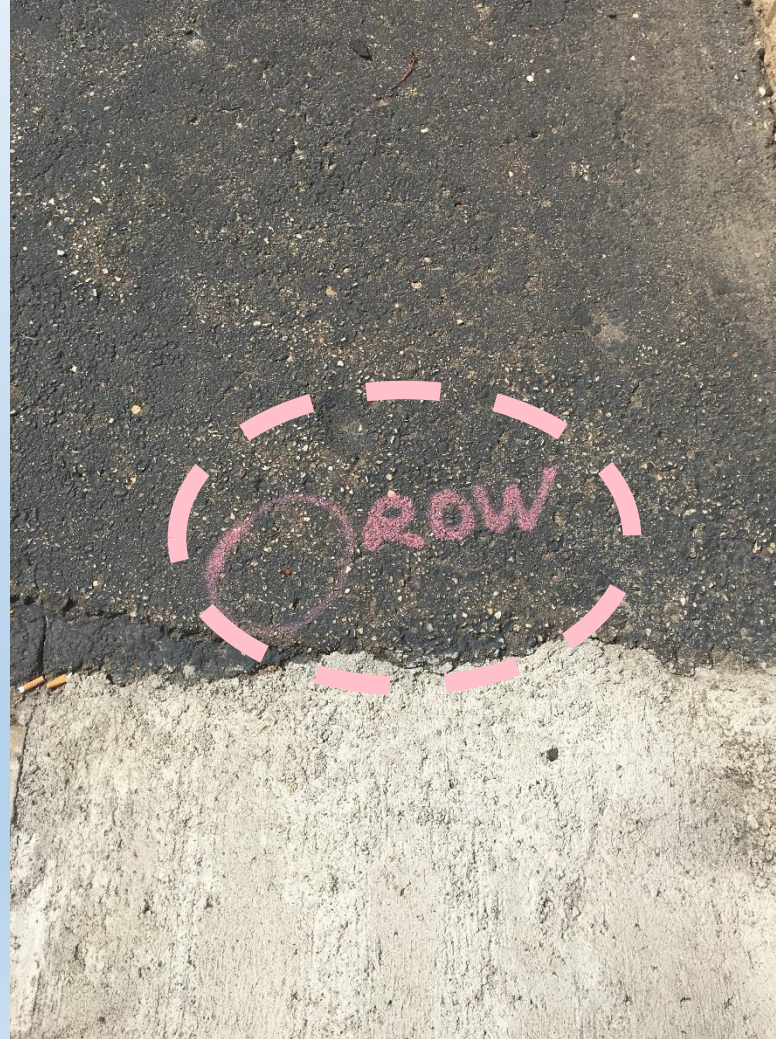
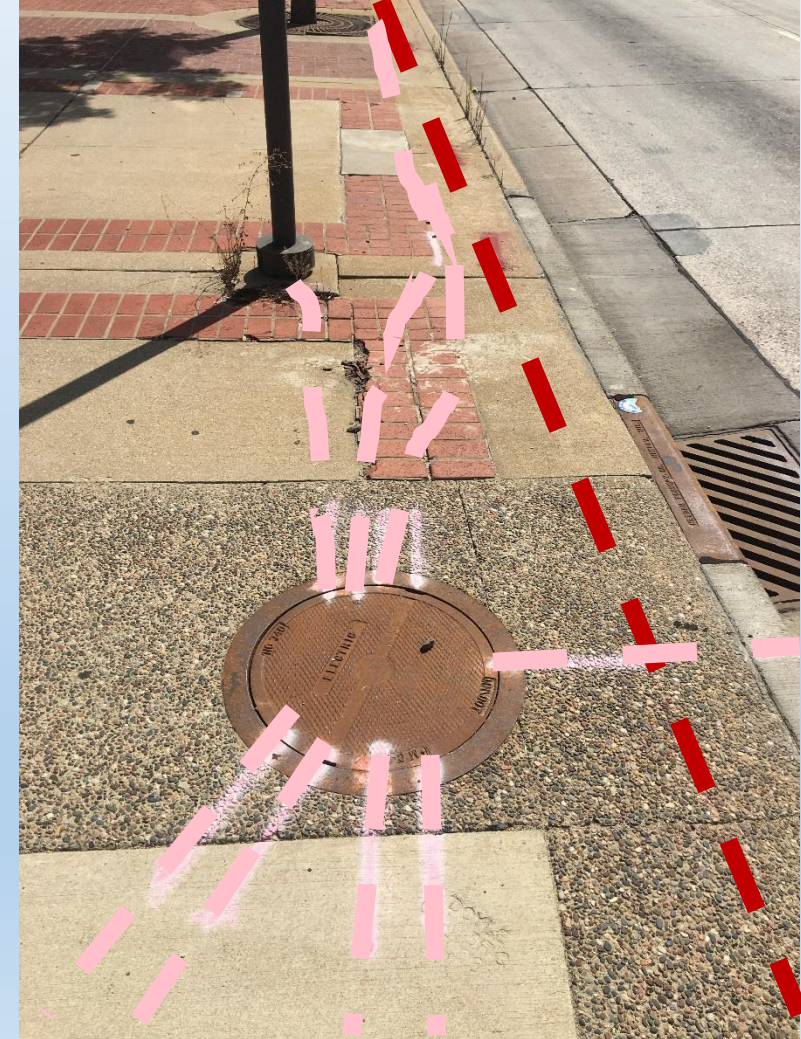
Investigation Around Site

- Utility was marking traffic signal wires with pink paint to distinguish between electrical lines
- Surveying onsite was using pink paint per APWA standard
- The excavator was not looking for pink paint because it doesn't represent a utility

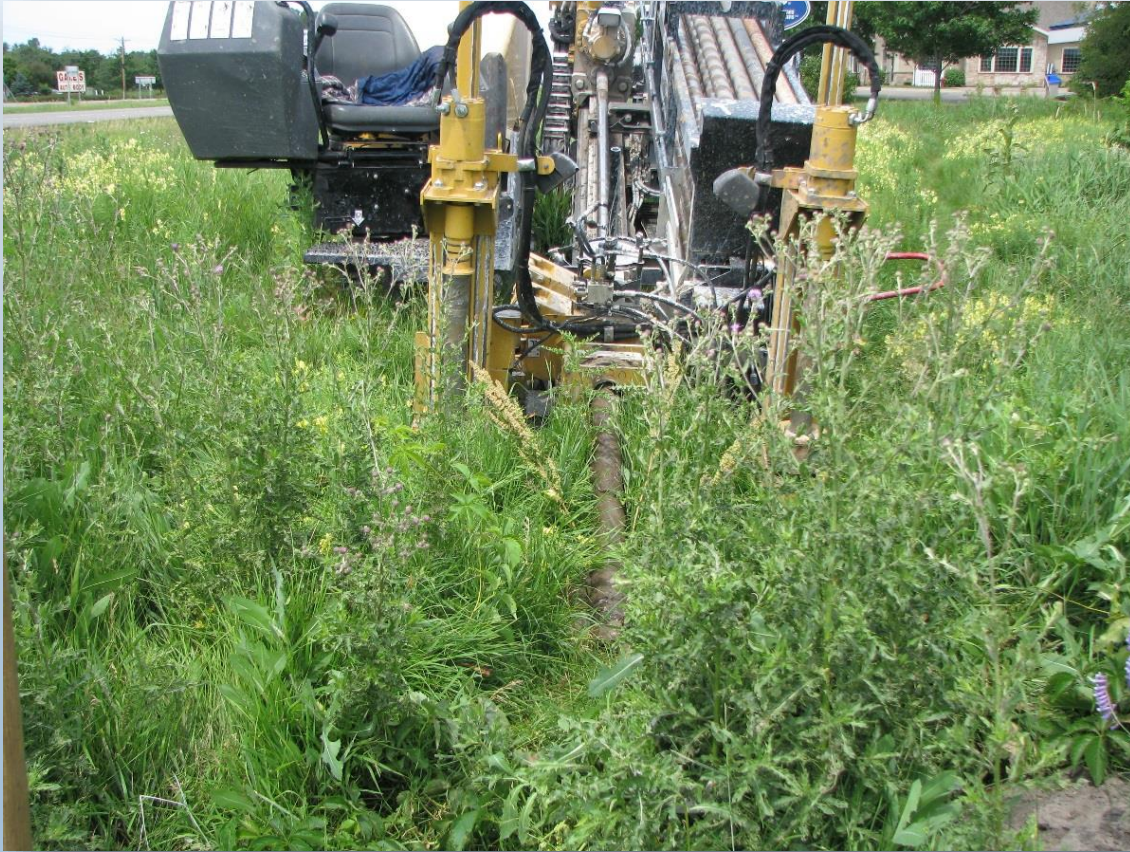
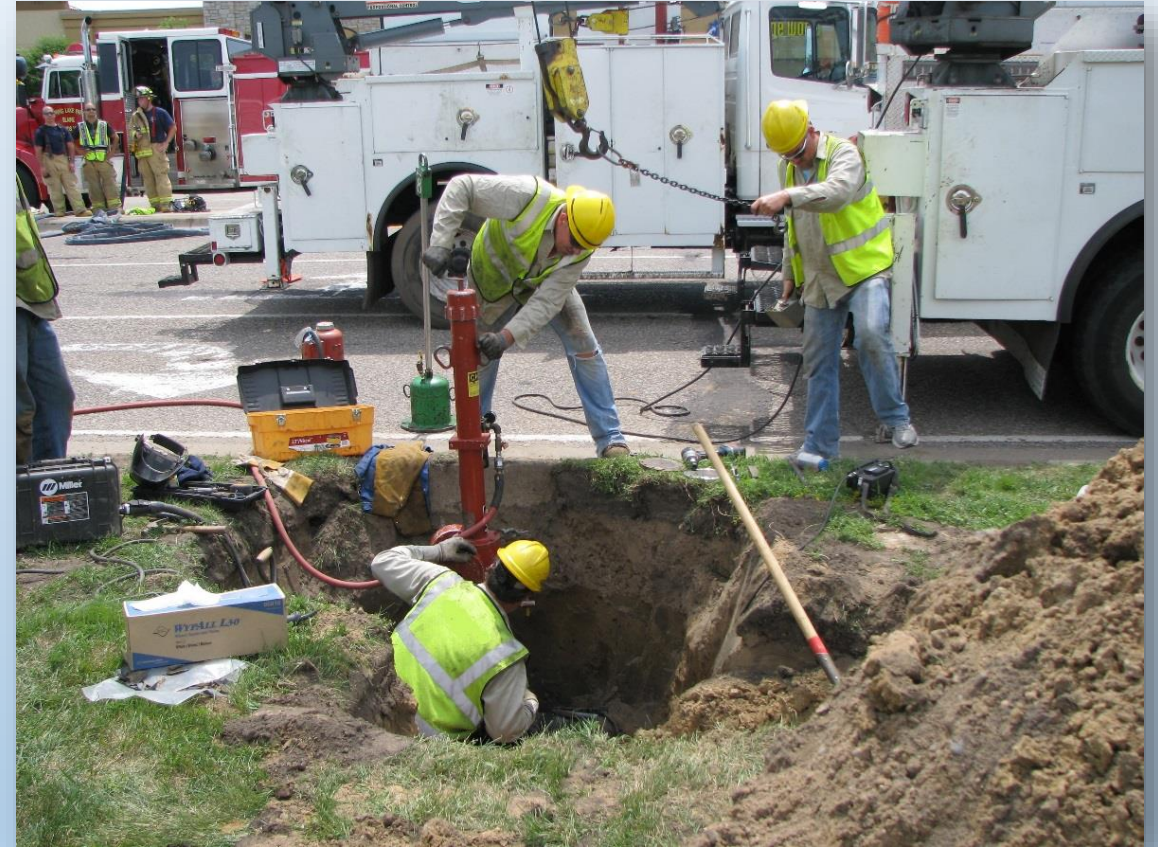
Excavating via HDD

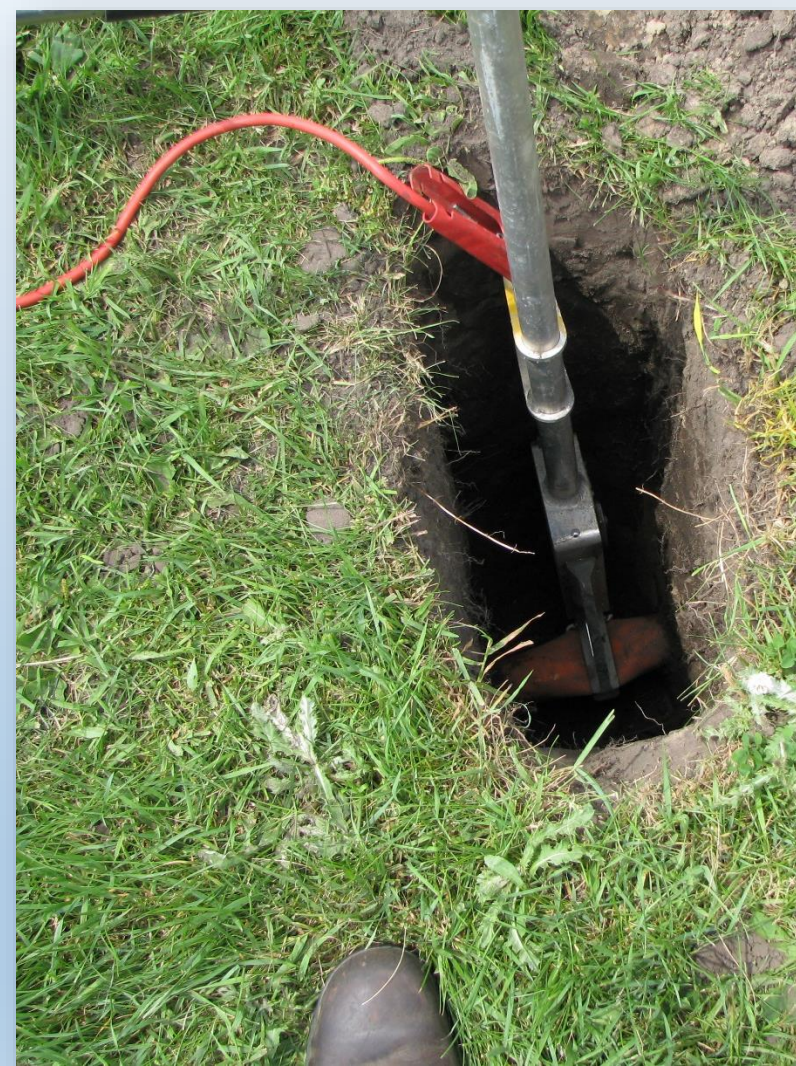
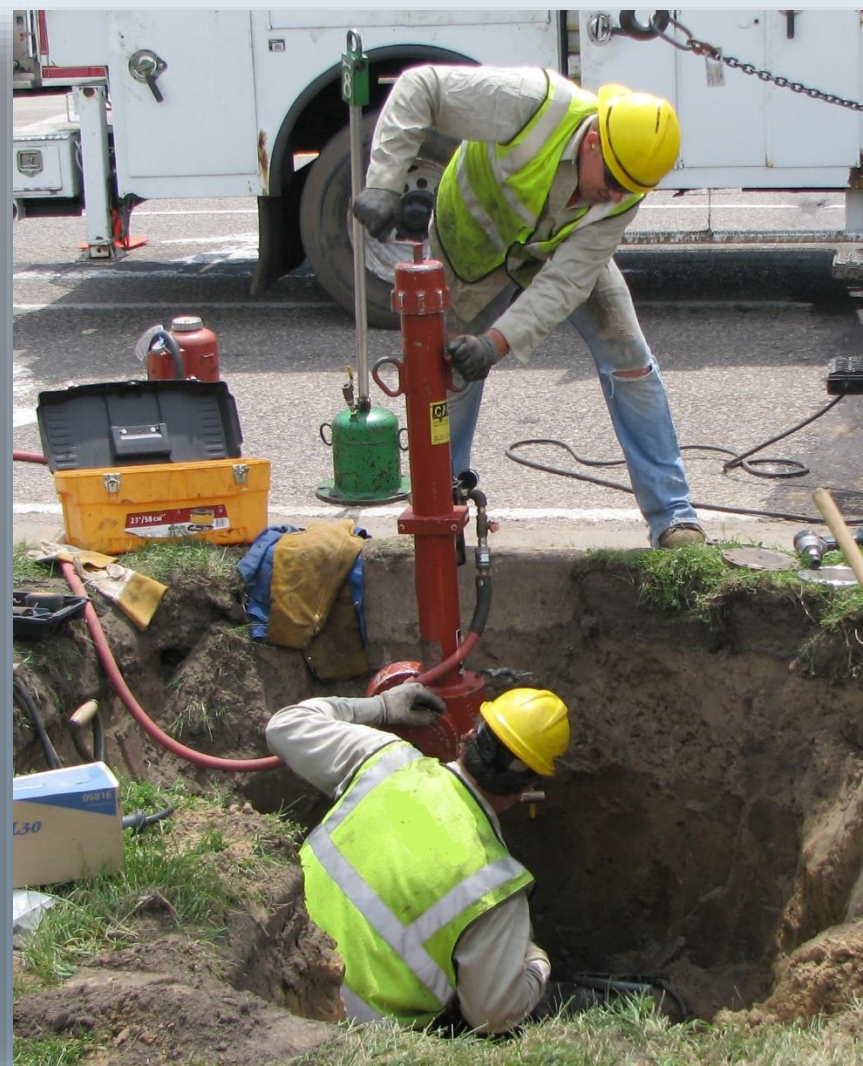
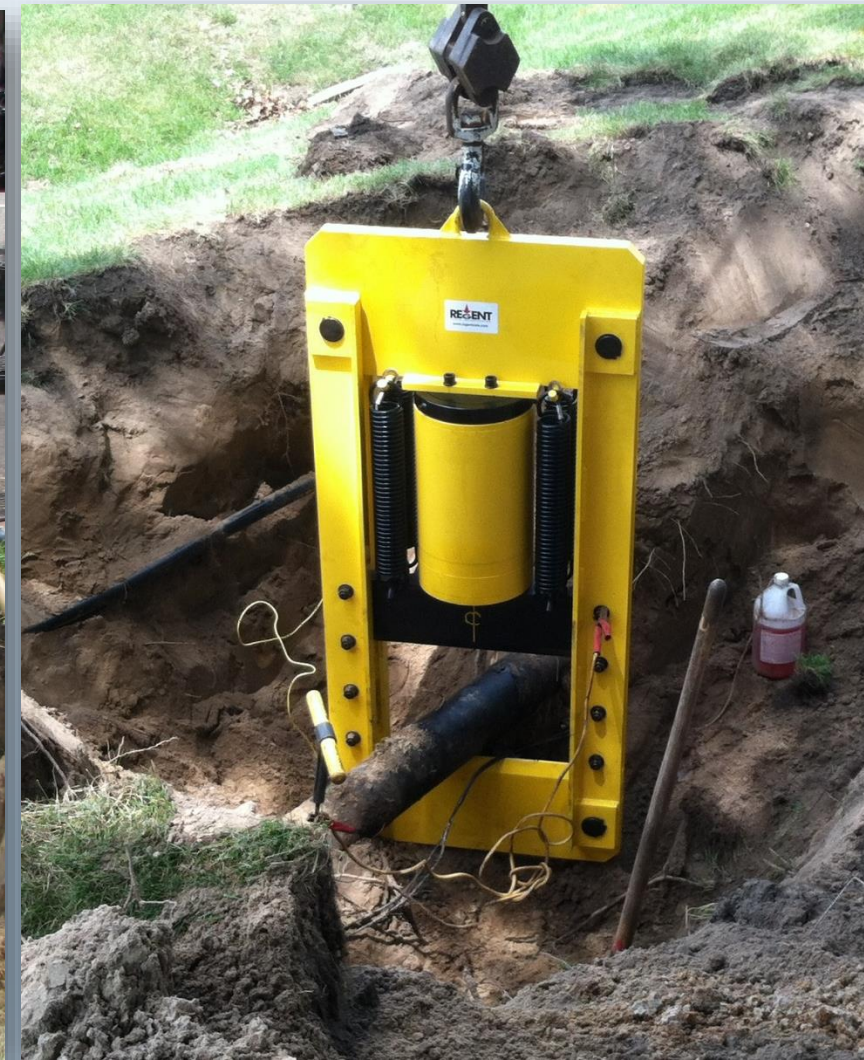
Case Study: Missing Marks

- **Utility did not mark all of their facilities in the scope of the GSOC ticket**
- **Excavator discovered missing marks, attempted to resolve on their own**
- **Excavator hit & damaged unmarked gas main**
- **If you notice marks missing or obscure, contact the facility owner!**
